17th November 2023

PERPURCHASE INSPECTION SURVEY

Moody 27

"Miss Moody"

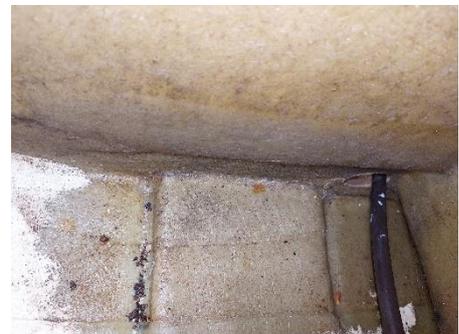
Ref 2.2

2.2 The Hull. The craft was built in Glass Reinforced Plastic (GRP) using unpigmented polyester resin with a good quality layup using woven roving’s and chop strand matt evident during inspection. The top sides were in white gel coat and not been painted. There were several painted stripes laid onto the top sides that would have been originally all tape. Generally presented in fair order with a few minor noticeable marks and scratches visible. The most noticeable recorded as to Stbd. a small poorly made gelcoat chip and a small area of vertical gelcoat fracture that was likely on a bulkhead. Some deeper scores to her forward Port quarter. There were several obvious repairs to the stem area including one where the gelcoat has faded off. On use of a moisture meter some elevated moisture in the repair noted. The hull was substantially stiffened throughout by using glassed in foam core stringers and frames that were well bonded in, there were also c12mm plywood frames with well match Teak faced bulkheads. There was clean faced teak fit out using 12mm lateral plywood stiffeners. Further set of reinforcements to stiffen her hull arrangements within the bilge areas around both of her keel attachment that produce a well-supported hull throughout. The Stbd. set were partly obscured by the water tank moulding. Some introduced expanding foam has been used in what was considered an attempt to seal her saloon side lockers from her bilge that were found wet. One small tear to tabbing in the aft Stbd. end of the support of her reinforcement that will require the failed tabbing grinding back and repairing. ***Make good torn tabbing in aft Stbd saloon bunk area for keel support. Try and remove retro fitted foam, suggest make good small gelcoat repair to Stbd. midships and monitor small vertical gelcoat hairline fractures. Monitor old stem repairs.***

Re tab torn laminate as noted.

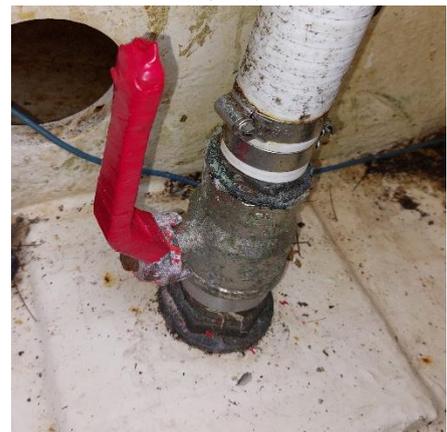
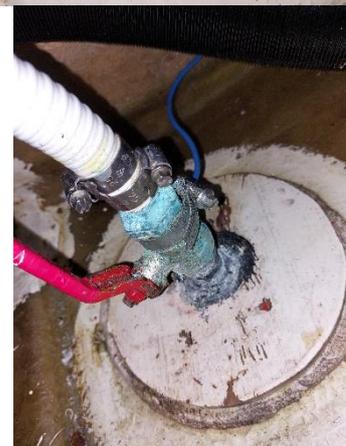
Ref 2.5

2.5 Skin Fittings. The craft had five under water skin fittings and an anode bar to her aft Port quarter near the “P” bracket. She also had four above water line through hull skin fittings covered in **2.5**. There were four underwater metal seacocks fitted. The remaining one was for a through hull log fitting. To the rear of the engine to Port there was one DZR brass ball valve seacock with PVC basket strainer for the engine intake valve. As viewed in serviceable condition, age reported as circa 3 years old. To Port under the aft end of the saloon bunk arrangement was a DZR brass ball valve for the head intake, corrosion around skin fitting and hose tail, it will require replacement of the whole assembly. Within the heads sink cabinet a sink discharge viewed with ball valve, the skin fitting viewed with obvious corrosion. This will require replacement. Within the aft Port cockpit locker a further DZR ball valve for the heads WC discharge. High corrosion viewed from the skin fitting hose tail connection, again recommend full replacement. all valves noted as bonded. *I recommend to replace the three complete seacock assemblies for heads intake and discharge plus heads sink, carefully monitor ongoing condition of the engine intake. Remove bonding of valves, see 10.1*

Discharge for Head discharge and intake both in poor condition. Note bonding.

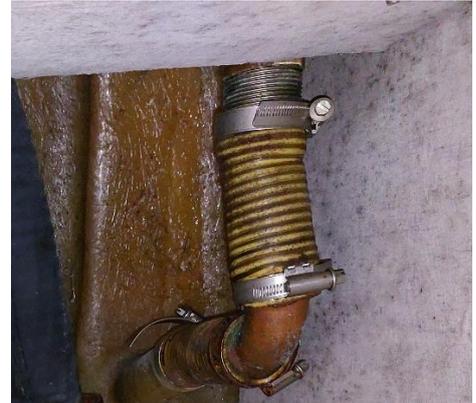
Ref 2.6

2.6 Skin fittings above waterline. The craft as noted had 4 above waterline skin fittings to her topsides. There were a pair of cockpit drains out through her transom. Internally very poor visual access to verify hose condition. The cockpit aft Port discharge hose considered old. To aft Port quarter a diesel heater discharge and bilge pump discharge noted. To Starboard her galley sink, a brass DZR ball valve fitted. A stainless-steel clamp fitted to attempt to bond the valve was failed. *See 10.1. Suggest replace cockpit hose and clamps.*

Cockpit hose drain as viewed may be in poor condition.

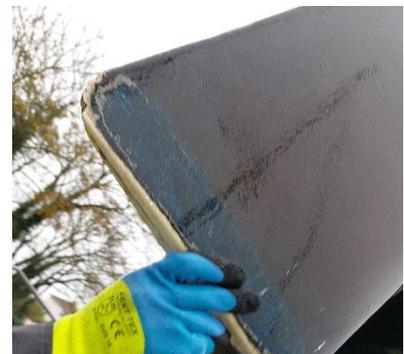
Ref 4.1

4.1 Rudder. The rudder was transom hung and was presented in a reasonably clean, well faired and balanced condition. The bottom of the blade with contact & tip damage, evidence of previously repaired to the tip noted. It is controlled from a solid ash tiller that is suitable for purpose but requires varnish stripping back and reapplication in the near future. The rudder blade was made from GRP, with the two-side compressed together. The gudgeon and pintles were in fair condition. All from Stainless steel. Internally from a candid photo moisture ingress through the lower fastenings noted. There was no significant play in the bearings detectable at present. *Repair tip of blade. Attend to lower fastenings.*

Rudder blade tip base damage.

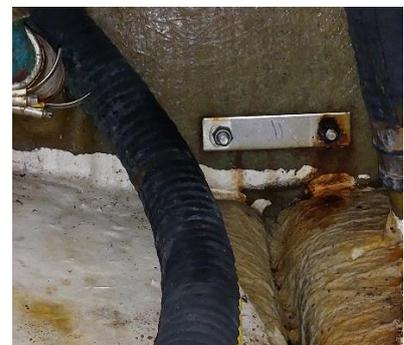
Lower gudgeon fastening with possible weep to fastening with corrosion.

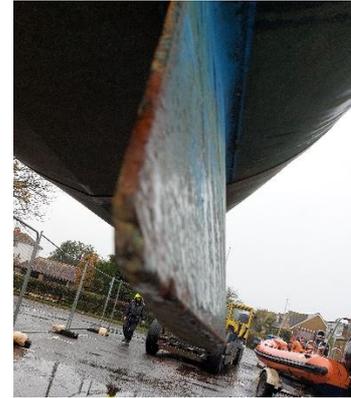
Ref 5.1

5.1 **Keels.** Externally the keels look in fair order they were made from cast iron with some minor signs of corrosion. both keels had some light corrosion and tip damage to the rear ends of both castings noted. Most likely from regular grounding at a tidal mooring in the past. There was some external disturbance of the mastic as applied to both sets of hull to keel joint noted. Were viewed some light surface corrosion in the abutment of the hull to keel joint developing. Internally not all fastenings were viewed due to the Stbd. set partly obscured by the GRP fitted water tank arrangements. Where viewed all were 1" sized iron fastenings with suitable nuts Port side was considered retro fitted with stainless steel large plate washers. A historic flow coating applied to the fastenings that has generally all failed allowing corrosion to most of the fastenings. No lock nuts were fitted. *The Studs were considered the originals with possible replacement nuts. With the indications of corrosion within the hull to keel abutments and the general internal condition of the fastenings. It is therefore recommended to clean and protect keel housings and deep clean and protect all internal fastenings.*

End of keels with damage noted.

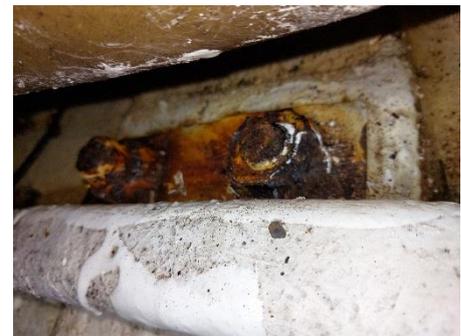
Obvious corrosion to Stbd fastenings.

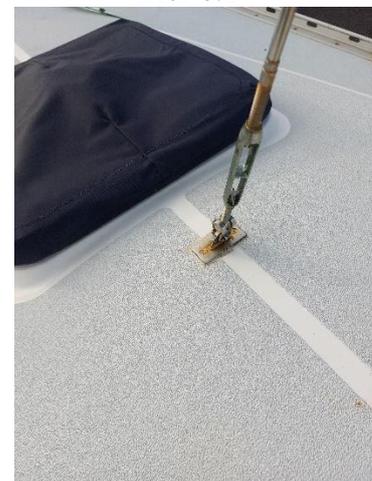
Ref 6.1

6.1 **Deck and cockpit areas.** The deck and superstructure mouldings were finished in white gelcoat with most of the side decks and working areas having course grit moulded nonslip surfaces. Finish generally in fair order. The cockpit areas also had the same finish. The side decks were uncluttered. The decks were considered as reinforced with Balsa core and plywood pads in high load areas. There are several fittings that were fitted through the top side mouldings. Attention is needed that a good seal to any deck fittings is maintained with regular inspections undertaken as moisture can ingress very easily. One small deck repair that may have been a hole saw for a fitting that was incorrectly position made good, to Port side of the coach roof some light damage and poorly finished with some light gelcoat crazing that could be easily refinished. I only found a few areas where the deck moisture readings were high. There were around the mast step arrangement with some evidence of light sloping aft of the deck plate, around both sets of chain plates to both sides and the baby forestay deck chain plate. As noted, the forepeak head lining was removed and evidence of moisture ingress was clearly identified. Aft to Stbd, moisture found in aft bunk lockers, found from failed cable gromet where wire has been removed. Deck and instrument deck plugs are notorious for allowing moisture into deck make ups and should be regularly checked.

Attend to moisture ingress to baby stay and balsa core

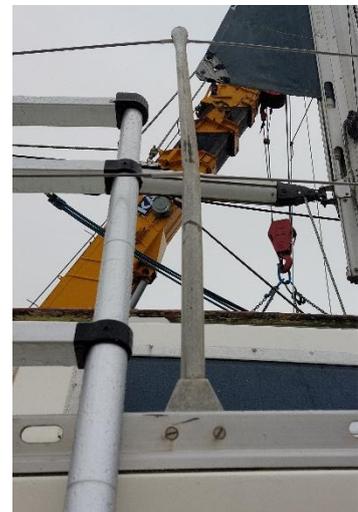
Ref 6.7

6.7 Guard Rails/Stanchions. There were three stanchions fitted to each side, the central stanchion to Stbd. and the rear one to Port side were bent. There is very slight flexing at the bases, but acceptable. The guard rail wires were in fair order. Age not confirmed. There was slight wear to the holes the wire passes through. Evidence of wires having been previously PVC coated. *Closely monitor stanchions and wire.*

Monitor stanchions and wire.

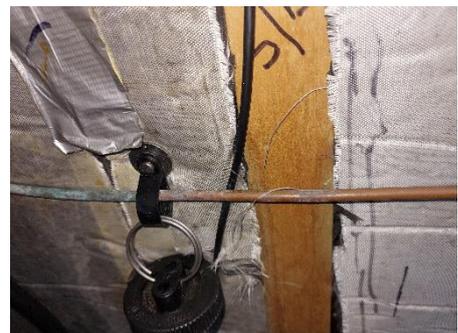
Ref 8.3

8.3 Gas Installation. There was a gas system fitted on this craft. I would recommend occasionally a qualified engineer checks the system. There was a Plastimo Neptune 2500 LPG twin burner, grill and oven cooker that had thermo cut outs fitted. The rubber gas pipe at the bottle end of the system was just in date. The armoured flexi hose to deliver the gas to the cooker was likewise just in service date 04/19. The copper pipe run where viewed was mostly in fair condition, however several areas of surface corrosion noted, especially from a candid photo under the cockpit aft, the pipework was not correctly supported through the engine compartment either. As noted, the bottle storage has a single vent overboard through that in the first instance discharges into the cockpit. There was no gas bilge alarm fitted to the craft. ***Ensure the flexi rubber hoses are replaced and system tested before use. Copper gas pipework should be correctly supported. Clean pipework. Generally, recommend hoses should be changed every five years, but exposure to UV light or tight turns in the hose can reduce serviceable life.***

Gas pipework not supported and with corrosion.

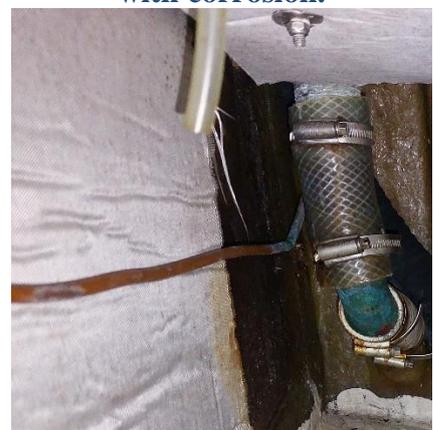
Corrosion and unsupported gas pipe under cockpit.

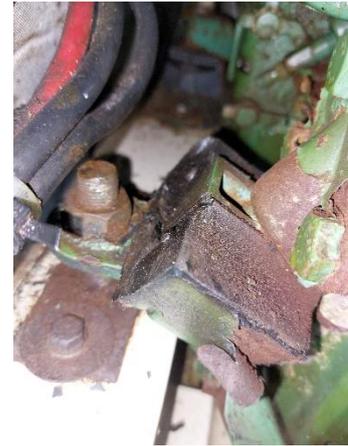
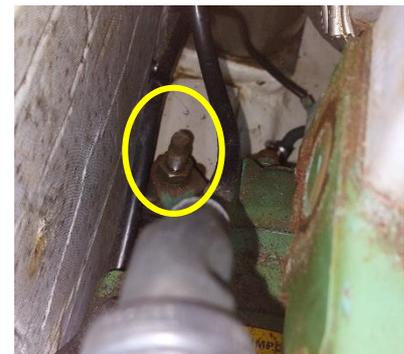
Ref 8.4

8.4 Engine Installation. The craft has an inboard diesel engine fitted. It was considered the original, it was a directly water cooled 2-cylinder Volvo 2002 model that is rated at c17hp with serial number FL10109. I did not start the engine or see it running ashore. No serious oil leaks found, one very minor rocker gasket leak potentially to Port forward that has run down over the forward engine mount. Under the engine and around the sump box it was reasonably clean.

Attend to loose mount nut and further check engine mounts underload as considered soft.

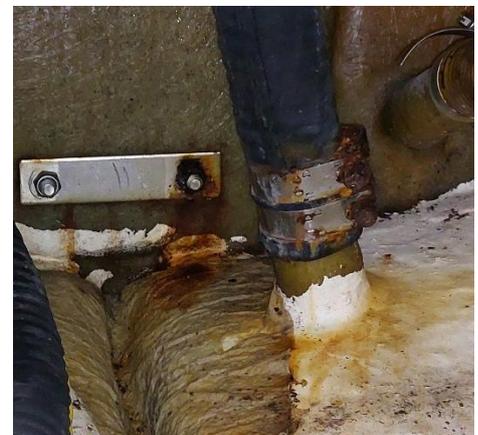
8.5 The water intake is via the seacock that was located under the cockpit sole. An inline PVC strainer fitted. The exhaust water was discharged through the exhaust system. The exhaust hose was run aft to a stainless-steel drum silencer fitted behind the engine before run back to the transom and swan necked before discharge to Port. Some corrosion and possible weep from hose joint noted. The system was not fitted with an anti-siphon device as such but a “tell tail” that was turned within the rear of the cockpit. *Consider fitting an anti-siphon valve on system instead of tell tail. Check discharge hose skin fitting seal and clamps.*

Check exhaust hose clamps.

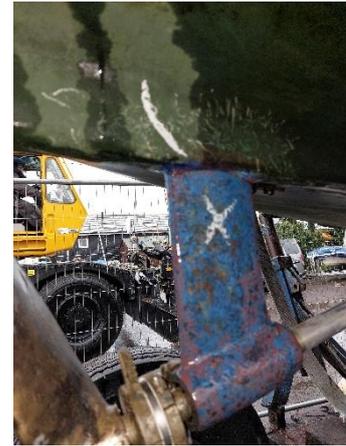
Ref 8.8

8.8 The craft has a stainless steel 1inch shaft fitted to a two bladed c17in RH Radice propeller fitted. There was a two bladed rope cutter fitted. The “P” bracket was found slightly loose and will require attention. As inspected the bronze casting was in fair condition. The bearing in the “P” bracket with very slight wear but not sufficient play at time of inspection for replacement yet. *The “P” bracket needs resecuring. I suggest monitoring the cutlass bearing with possible replacement required of bearing at end of next season depending on amount of use.*

Attend to loose “P” bracket.

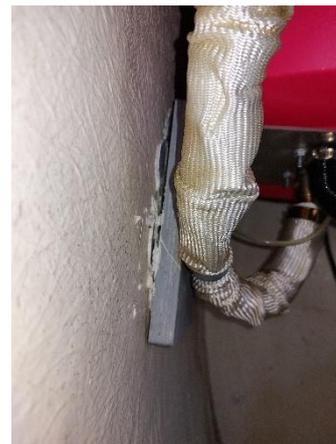
Ref 9.5

9.5 Heating system. Within the port locker there was diesel air heater noted as manufactured by Parking Heater-Air heater with model No. ZM5001 1-5Kw fitted. The units support bracket was poorly glued to the hull laminate, there were a number of safety issues noted with the unit that need attention before use including the poorly insulated insulation and distance away from hull laminate of the exhaust run.

Cont. I did not see the system run. Fuel line of PVC that is not appropriate. The exhaust discharge out to Port topside, care should be taken with the position of the outlet with fenders etc. as the outlet will become very hot when in use. I also noted there was a carbon monoxide alarm fitted. ***The unit should be correctly installed before further use. I suggest getting a professional inspection.***

Attend to diesel heater installation.

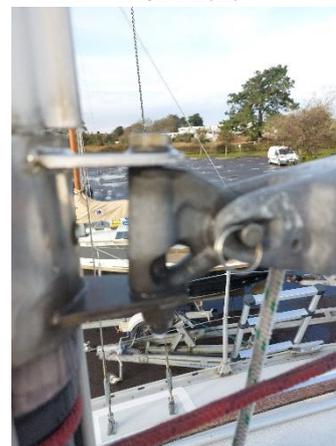
Ref 11.1.

11.1 Mast The rig was a masthead rig. All sections were made by Kemp and were of silver anodised. A retro fitted Easy Reef main sail furler fitted. mast serial number noted 329x8. All fittings secure. The spars were all clean and fair with no signs of impacts. The gooseneck fittings have worn out due to spacer washers missing. In mast furling not proven. The roller reefing was considered a Profurl system and as viewed in serviceable condition. The forward PVC lock needs turning upwards. Foils as sighted in fair condition. ***Fit spacer washers to gooseneck. Check in mast furling is working satisfactorily. Ensure roller PVC locks correctly positioned.***

Attend to wear in gooseneck By fitting washers.
