## “MISS MOODY”

**Yacht Type:** Moody 27

## “MISS MOODY” Pre Purchase Survey Report

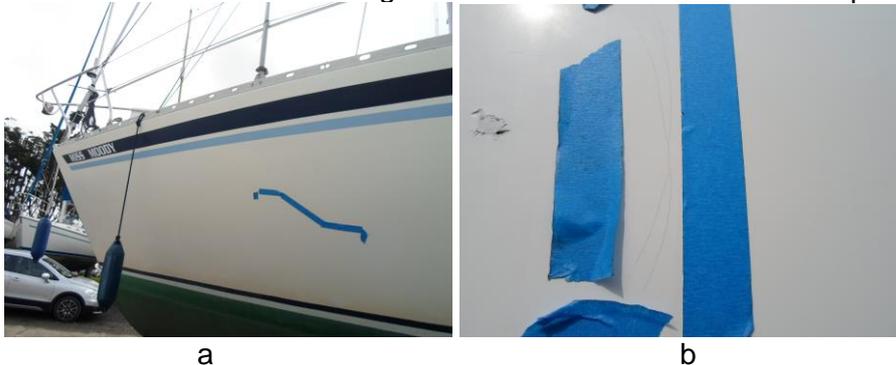
- 1.1 There have been a number of minor repairs carried out to the topsides over the years, there is a deep mark in the gelcoat on the port side below the blue tape in photo a and a small area of stress cracks with a small repair just aft of these that is becoming detached on the starboard side in photo b below

- 1.1 The next time you have a laminator doing any work on the vessel you should consider getting the stress cracks chased out and the failing repair hooked out, these areas will then need to be cleaned out with acetone before the repairs are carried out.
- 1.10 Before the vessel is launched the surface of the Coppercoat antifouling needs to be abraded with a green scouring pad to reactivate it.

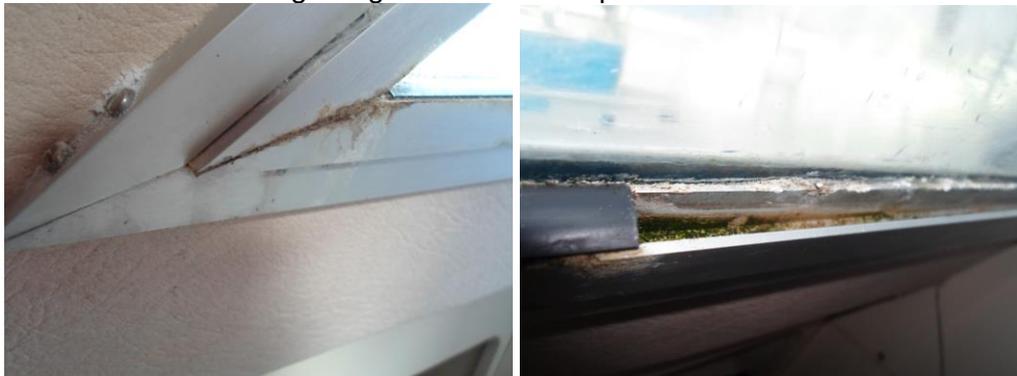
- 2.7 The glazing in the fixed windows in the in the coachroof sides are found to be starting to suffer with UV crazing and the aft end of the port window in the coachroof is showing evidence of leakage on the seal between the window frame and the glazing in the toilet compartment

- 2.7 You should hose test the port aft fixed window in the side of the coachroof and if it is confirmed to be leaking between the frame and the glazing you might want to consider removing this and sending away to be resealed and either of the following companies could help you with this:

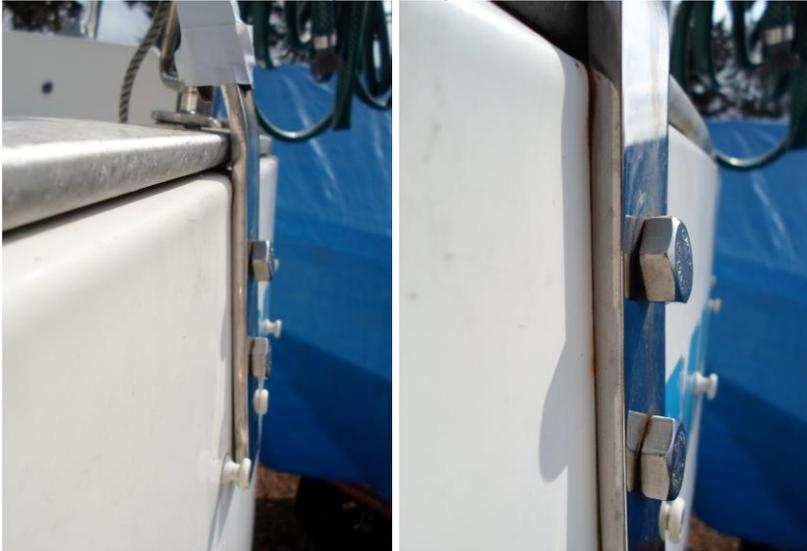
- 2.12 The stainless steel cap shroud and aft lower shroud chainplates are a through deck type, these are attached to vertically laminated partial bulkheads below the deck and the condition of these could not be inspected as they are boxed in by the joinery. The babystay is attached to a stainless steel through deck type chainplate; this is believed to be attached to the underside of the deck. There are cover plates fitted to the deck surrounding the through deck chainplates to seal up the hole cut through the deck. The forestay is attached to the stemhead fitting which has a tang welded to it running down the stem, this is bolted through the deck and the stem. The stainless steel backstay chainplate is bolted through the transom. The backstay chainplate looks like it has moved up the transom because the bolt heads are no longer sitting flat onto the surface of the stainless plate

- 2.12 *You will need to make sure the backstay chainplate bolts are done up tightly. You will need to hose test the port cap shroud chainplate and if confirmed to be leaking when the mast is out to replace the standing rigging you will need to lift the cover plate and reseal the hole cut through the deck. I suggest you remove the old sealant around the chainplate and pack the bottom of the gap around the chainplate with caulking cotton before putting sealant around this and the deck cover plate should be bedded down onto fresh sealant (you might want to consider doing this to all of the chainplates).*

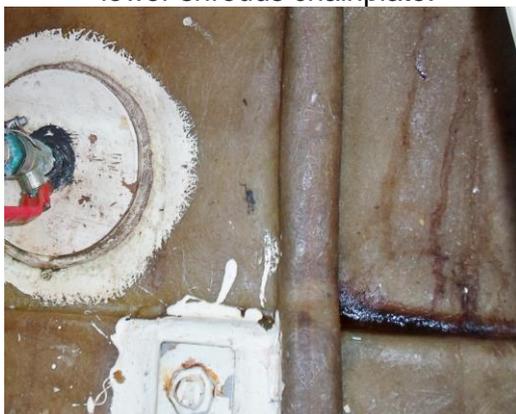
There are dark coloured water stains running down the inside of the hull under the port settee in the saloon and some dark coloured water on the top of the recess in the hull for the keel stub and this is in the area below aft lower shrouds chainplate.

- 2.13 **The joinery below deck will need to be removed so that the underside of the deck and the chainplates are exposed. Core samples in the wet areas should be taken from the underside of the deck in the areas of the high moisture meter readings and if the core material is wet or dark this will confirm the ingress of water. The vessel will then need to be revisited so that a further inspection can take place and following this inspection a recommendation on the course of remedial action required will be made.**

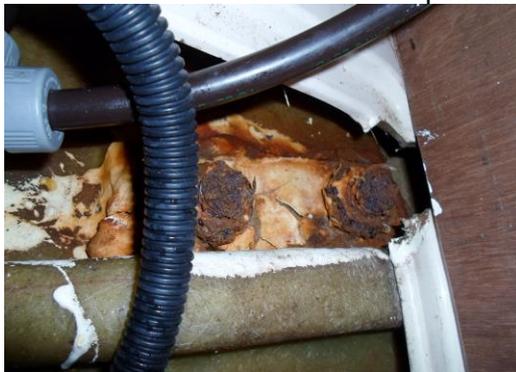
Keel bolts and nuts under the galley

- 3.1 The vessel is fitted with grey cast iron bilge keels; the keels are in a good serviceable condition and there is no evidence of the boat having been grounded heavily. There are no signs of cracks in the surface at the corners of recesses in the hull for the keels.
- 3.2 The keels appear to be well installed, however I am unable to comment on signs of movement at the keel to hull joint interface as the boat was already ashore and sat on its keels.
- 3.3 The keel bolts are from high tensile steel, the bolts and their backing plates where accessible are found to be suffering from surface rust and the worst affected are those under the galley and the keel bolts under the water tank are not accessible for inspection.

- 3.2 *When the vessel is lifted the keel to hull joints should be checked for any signs of movement.*
- 3.3 During your next winter layup ashore you should remove the water tank from the starboard settee in the saloon to check the condition of the keel bolts etc. You should also check on the stiffening in the way of this keel. All of the keel bolts nuts and backing plates will need to be cleaned up and if they are still in a serviceable condition they will need to be treated with a rust inhibitor before they are repainted. Any nuts and backing plates that are not found to be serviceable will need to be replaced (this should be carried out 1 at a time so as not to disturb the sealant between the keels and the hull).

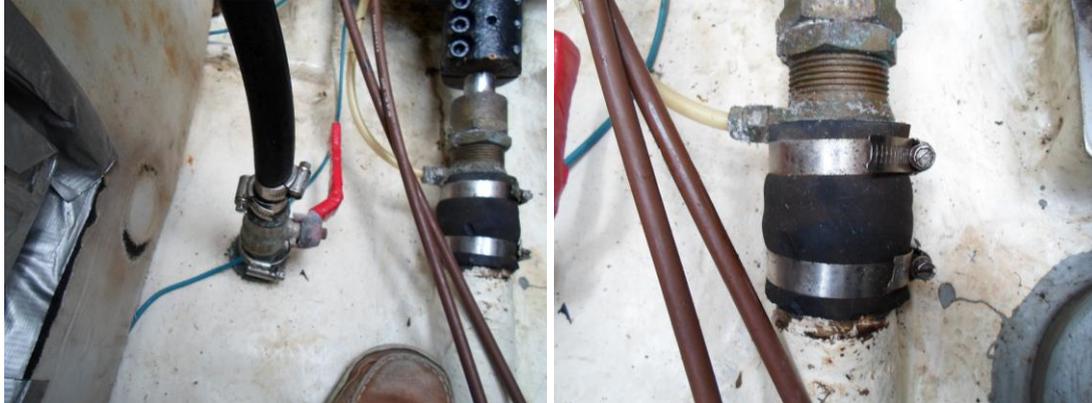
- 5.5 The stern tube is fitted with a conventional packing gland and this has been repacked in the recent past as there is plenty of adjustment in this. This is fitted with a greaser which is located at the aft end of the port engine bed and there is plenty of adjustment left in this.
- 5.6 The stern gland is attached to the stern tube by a rubber hose which looks to be swollen and it is only secured with a single hose clip at either end

- 5.6 **The age of the rubber hose connecting the stern gland to the stern tube needs to be established and if this is over 10 years old it will need to be replaced. Double up on the hose clips at either end of the rubber hose or replace the hose clips with hose clamps**

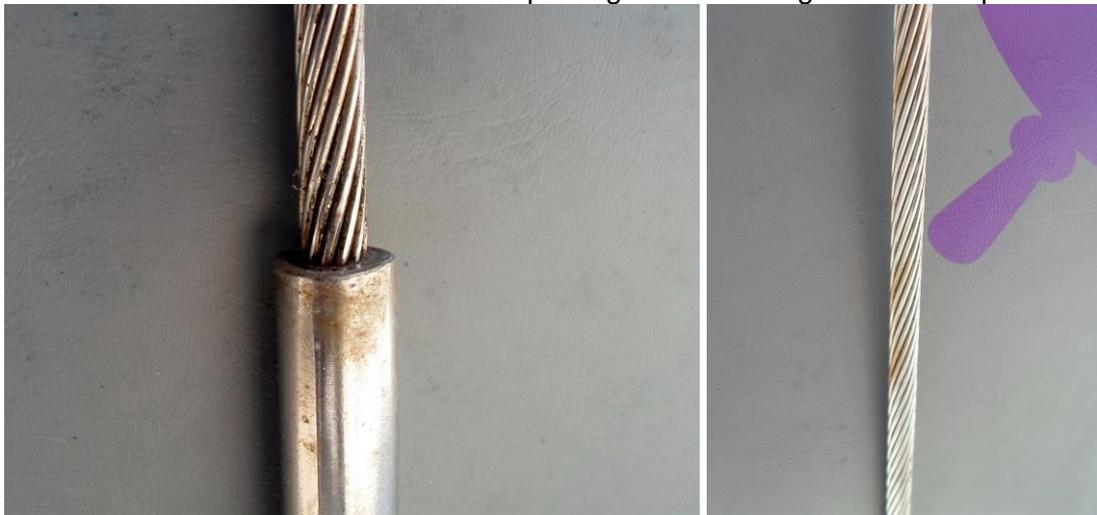
- 9.2 The standing rigging is 1 X 19 stainless steel wire and fitted with swaged on type rigging screws (new in 2004). The condition of the wire where it enters the swages at the bottom was checked with a 7X magnifying eyeglass and whilst there are no apparent signs of any broken wires or splits in the swage terminals there are signs of wear on the surface of the wire strands because there have plastic parell balls fitted to them. The babystay also has a nylon shroud roller fitted it. There are spiraling stains running down the cap shrouds

- 9.1 *When the mast is un-stepped to replace the rigging a full inspection of the mast should be carried out, paying particular attention to all structural parts for: cracks, deformation, wear/play, fastening, corrosion and if plastic ageing. That moving parts are moving freely. The wire where it enters any swage fittings and the swage terminals themselves and the running rigging for unusual wear on the cordage and whippings. With the mast down it is recommended that the all the moving parts are serviced as required.*
- 9.2 **The standing rigging needs to be replaced and do not refit the parell balls or the nylon shroud roller**
- 9.4 *You will need to get a rigger to adjust the tension on the foil in the Easyreef in-mast reefing system*
- 9.9 *The telescopic spinnaker pole needs to be serviced*

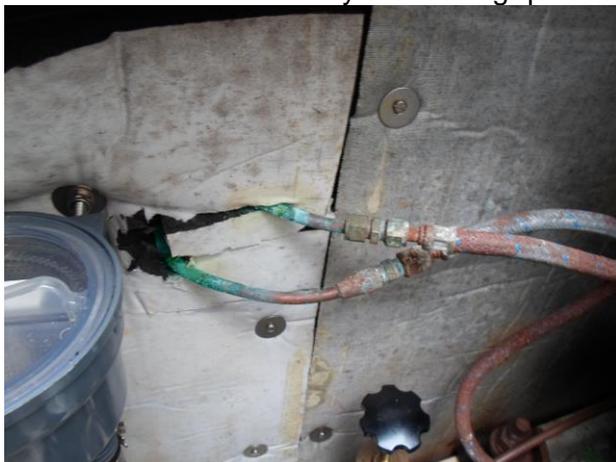
- 12.2 The filler/vent connections are in a good condition and the filler is located in the port cockpit seat above the tank
- 12.3 Both the fuel supply and return lines from and to the tank are seamless copper tubing. The supply is connected to a water separator and on towards the engine where it is connected to an armoured flexible rubber fuel hose and the armoured flexible rubber fuel hose from the leak off rail is connected to the copper pipework going back to the tank. The age of the flexible hoses is not known and they are looking quite rusty in their appearance.

- 12.3 *Flexible rubber fuel hoses are considered to have a service life of 10 years, due to the fact these are rusty in their appearance and no longer as flexible as they used to be these will need to be replaced. The replacement rubber fuel hoses should be in accordance with the requirements of ISO 10888 and be type A1 or A2 hoses in accordance with ISO 7840.*

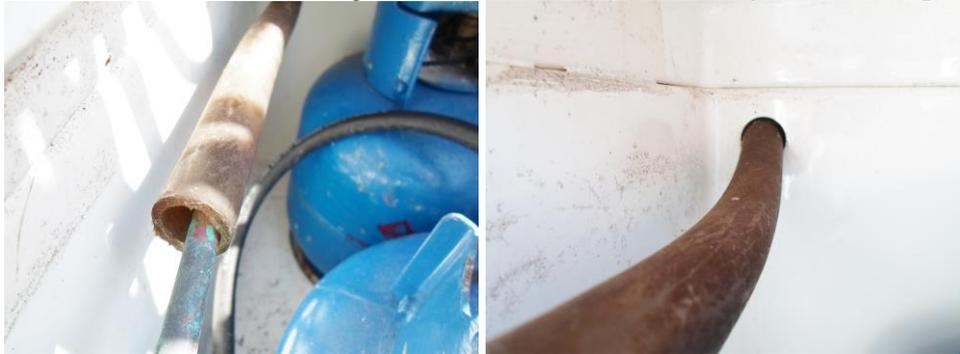
- 13.1 The gas bottle locker is located at the aft end of the starboard cockpit seat, this drains into the cockpit and overboard via the cockpit drains. The locker in the event the drain became blocked would vent to vessels interior via the hole in the end of the plastic hose the copper pipework has been run in and the hole in the back of gas bottle locker that the hose passes through.

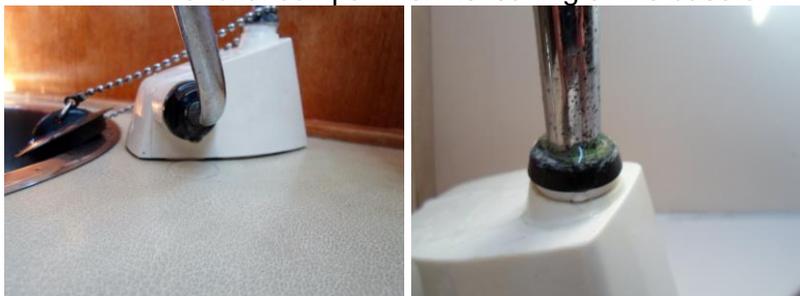
- 14.1 The GRP water tank is fitted to the starboard saloon settee/berth, the filler and vent connections on the tank looked to be OK and the tank has been drained down for the winter
- 14.2 The water filler cap is located starboard side of the deck.
- 14.3 There is no contents gauge fitted
- 14.4 There is a Whale flipper hand pump in the galley and in the toilet compartment, the pump in the galley is leaking on the pumps handle and the 1 in the toilet compartment is leaking at the base of the faucet

- 14.4 The Whale flipper hand lift pumps need to be serviced, the water tank will then need to be filled and the air bled out of the system. The pumps will then need to be checked for leaks.
